Debris/Ice/TPS Assessment And Integrated Photographic Analysis For Shuttle Mission STS-49

July 1992

Shuttle Mission STS-49 was launched at 7:40 p.m. local 5/7/92

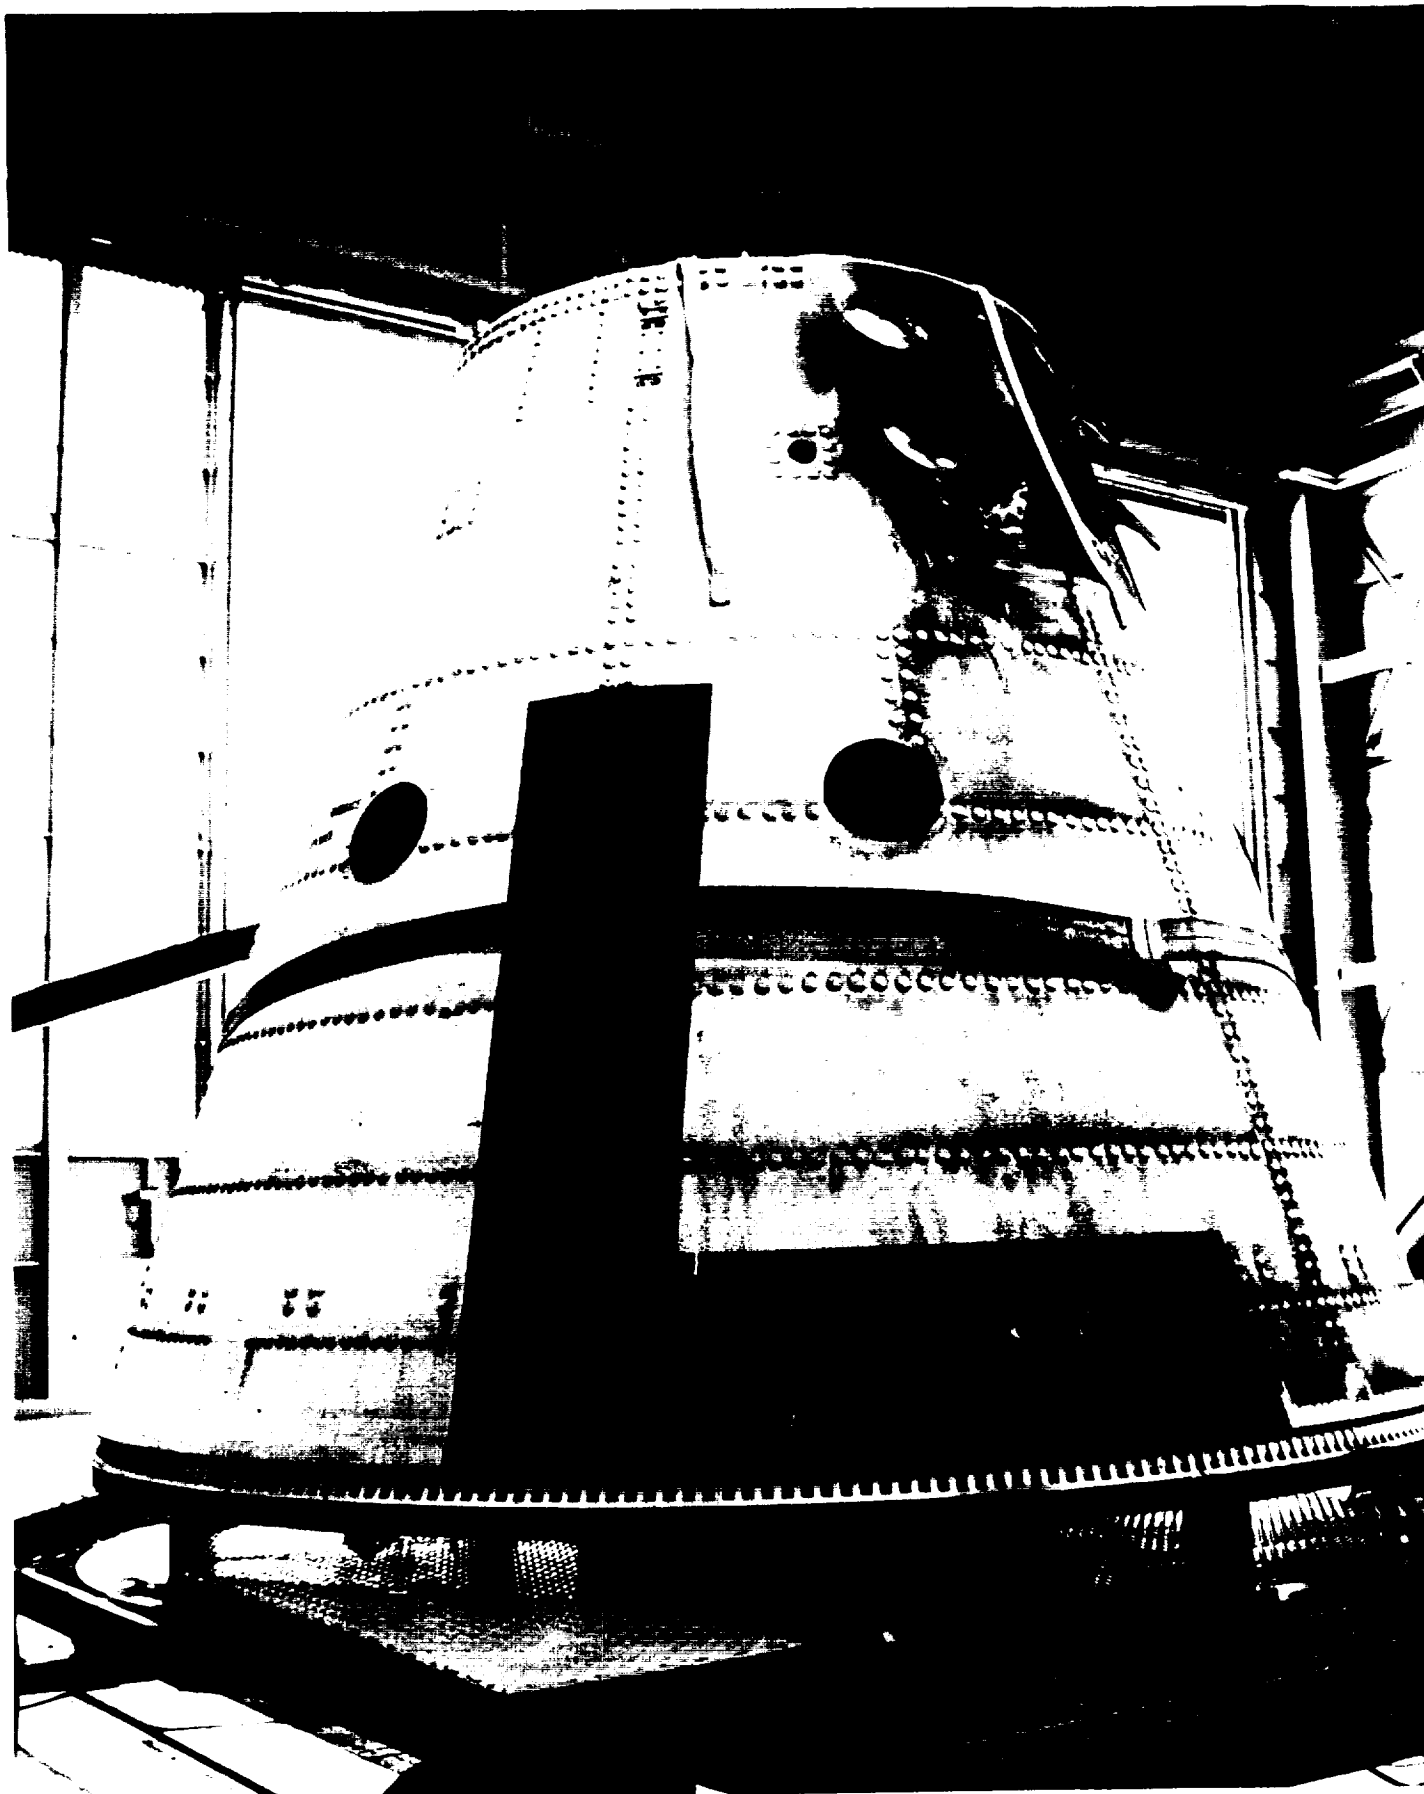
The LH frustum was missing no TPS but had 9 MSA-2 debonds over fasteners. There was minor localized blistering of the Hypalon paint. The BSM aero heat shield covers were locked in the fully opened position.

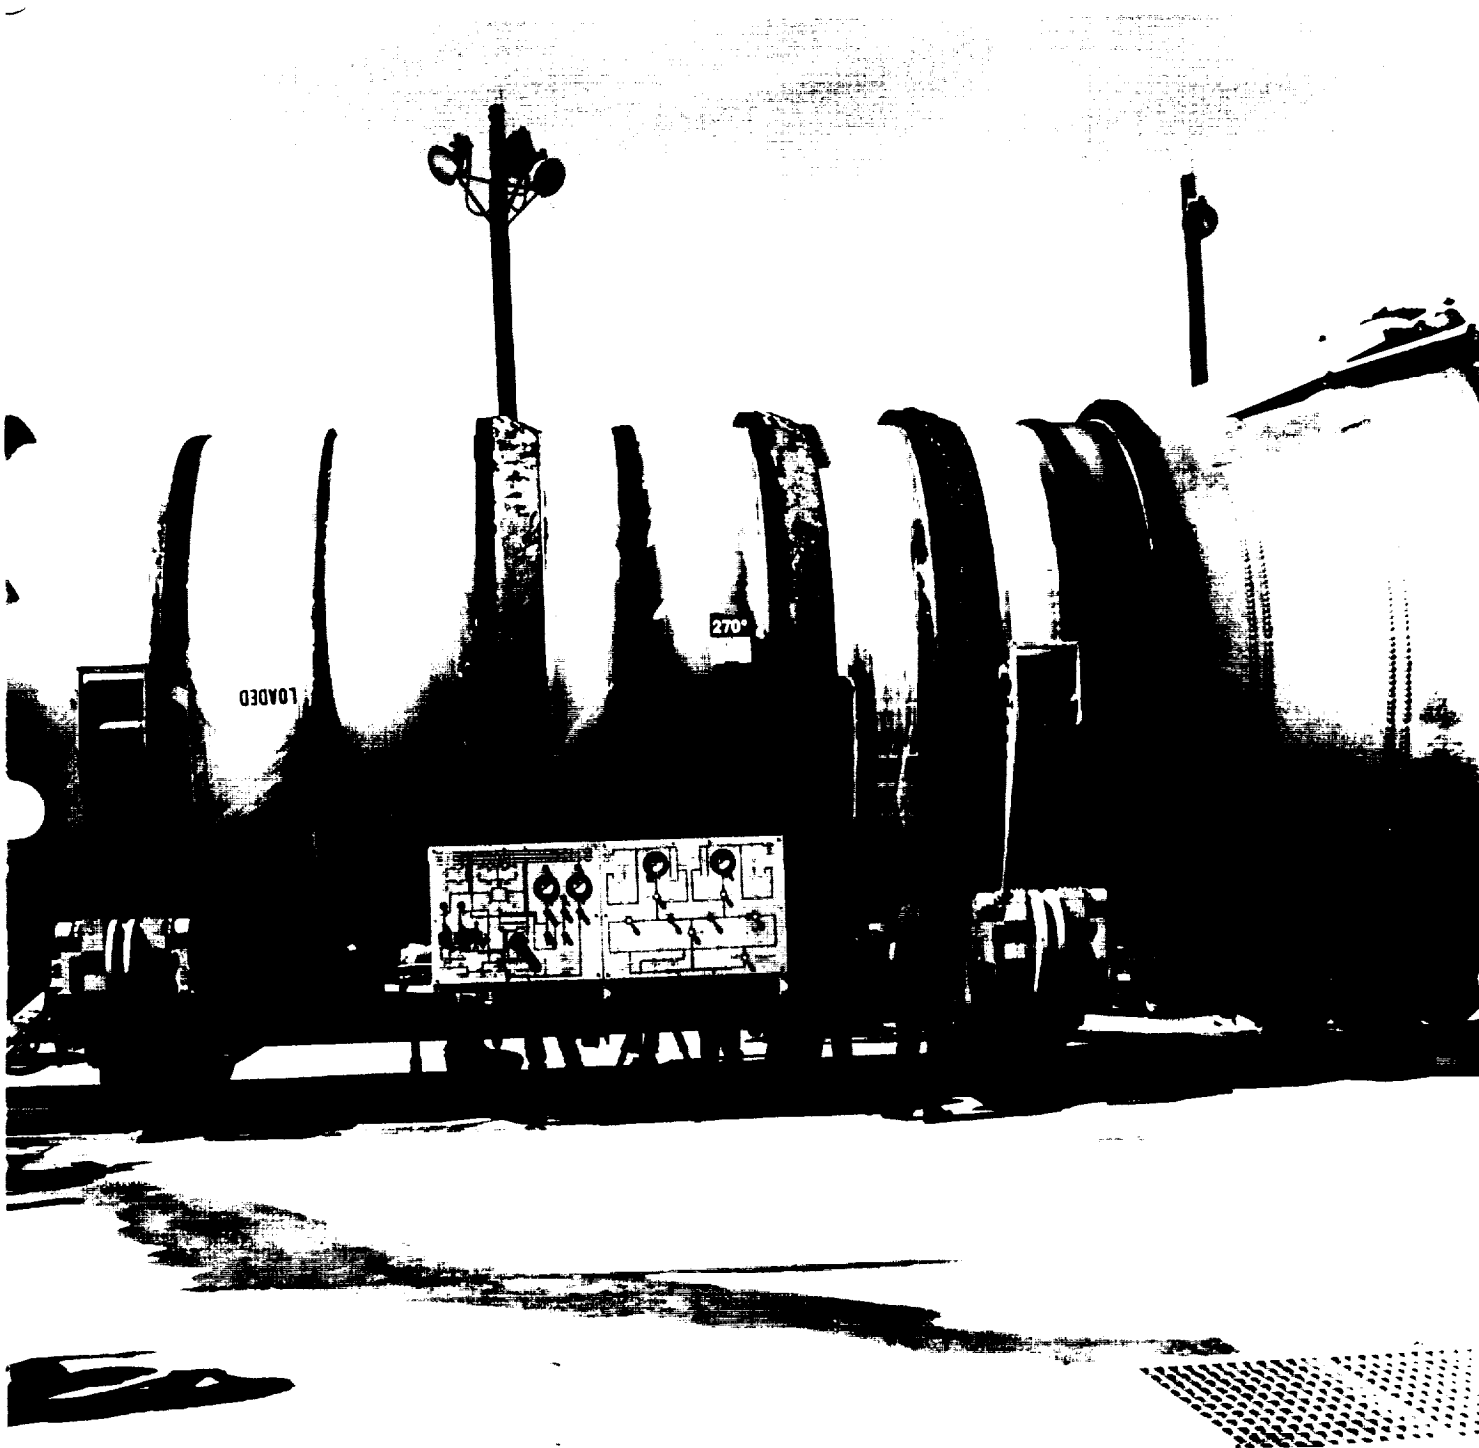
Post flight condition of the LH aft booster/aft skirt. The aft skirt acreage TPS was sooted but generally in good condition. The ET/SRB aft struts, IEA, and ETA ring appeared undamaged. All three aft booster stiffener rings sustained water impact damage.

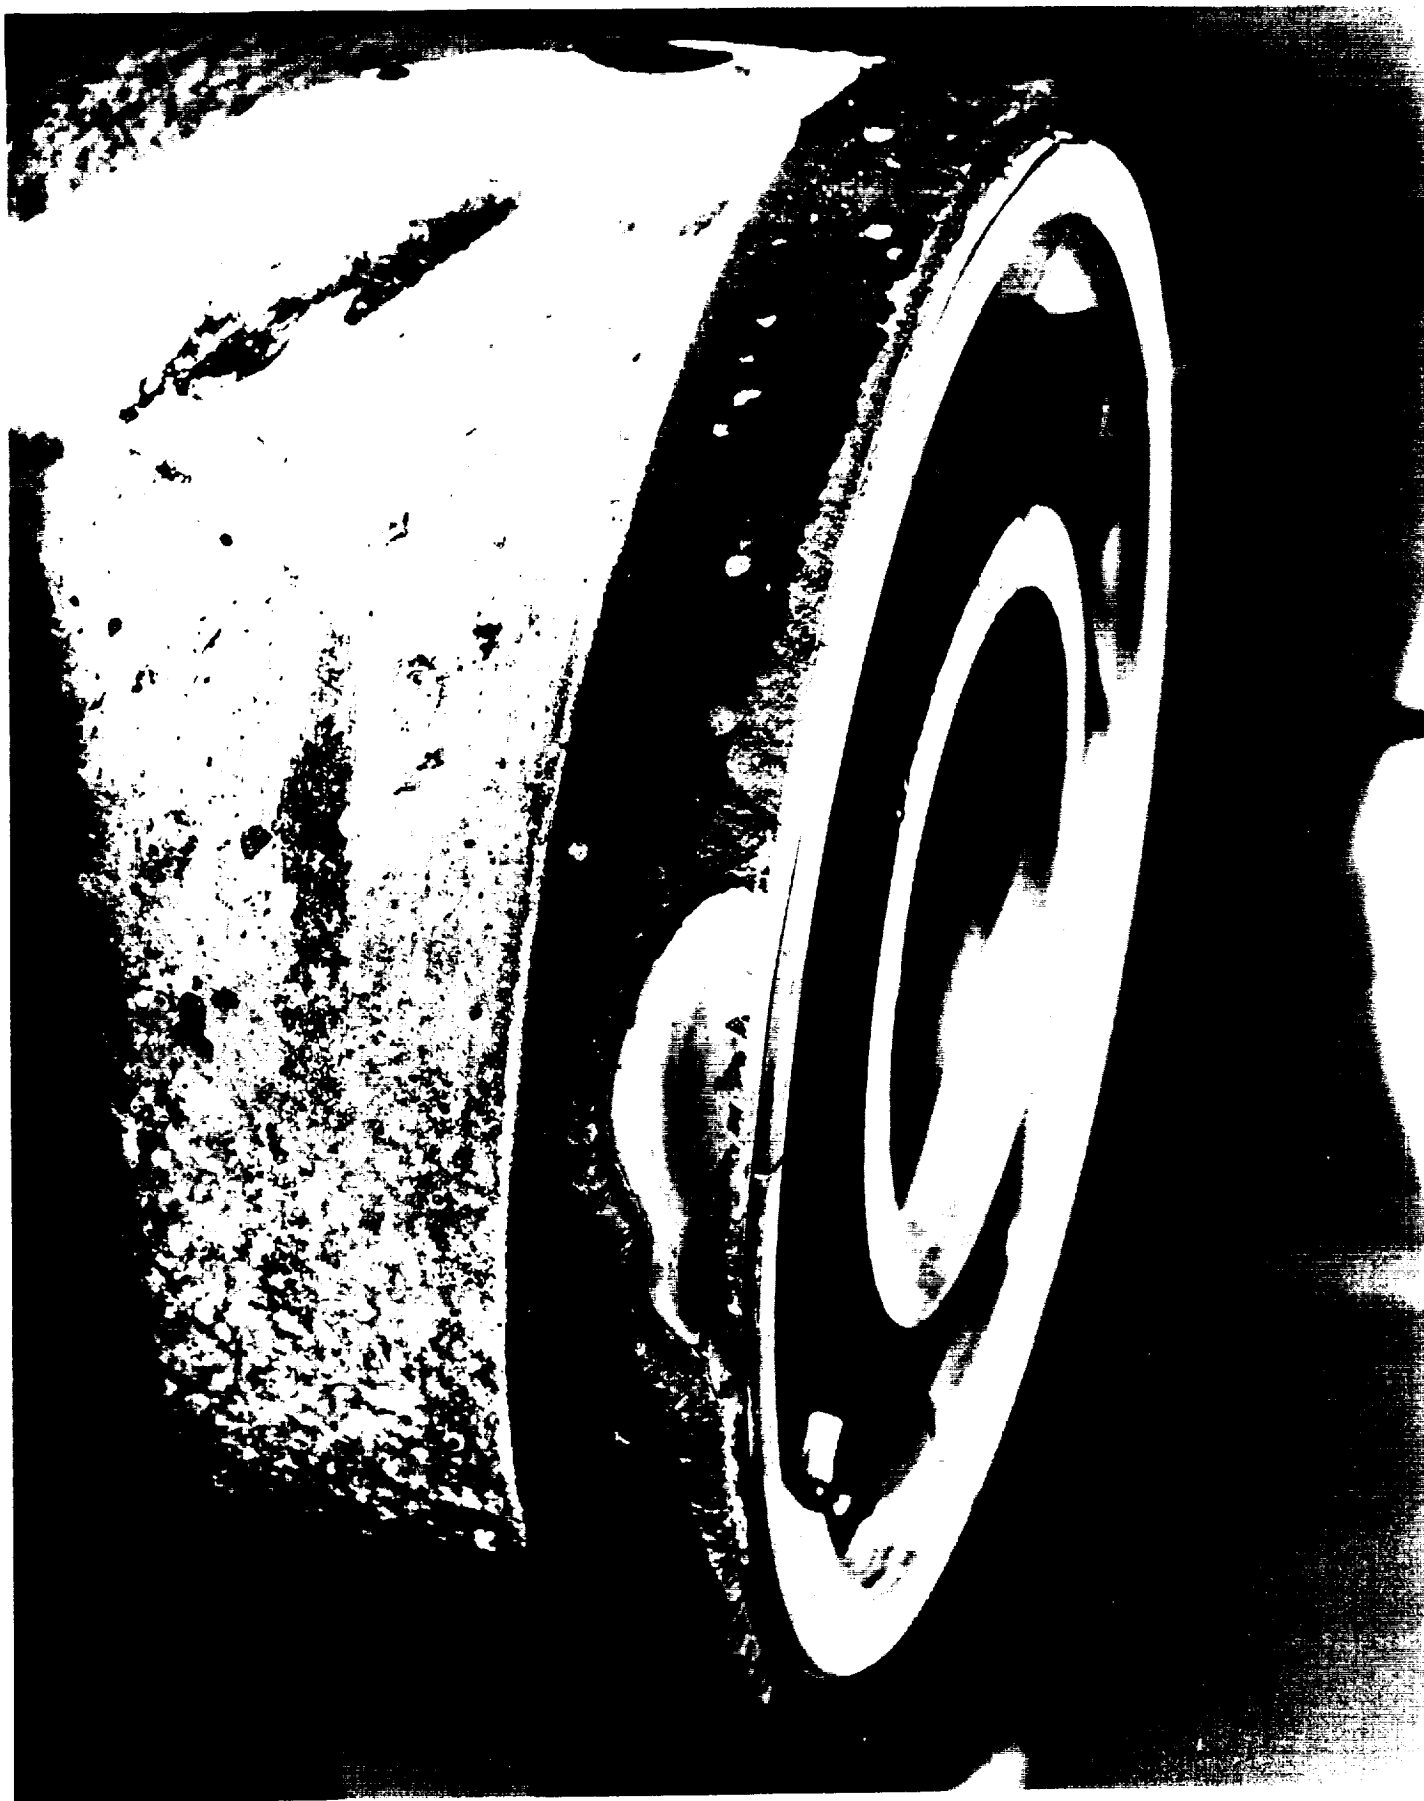
A 4.5"x3" area of TPS on the forward side of the upper strut fairing at the separation plane was missing and the substrate showed signs of heating. The loss of TPS may have occurred during strut separation.

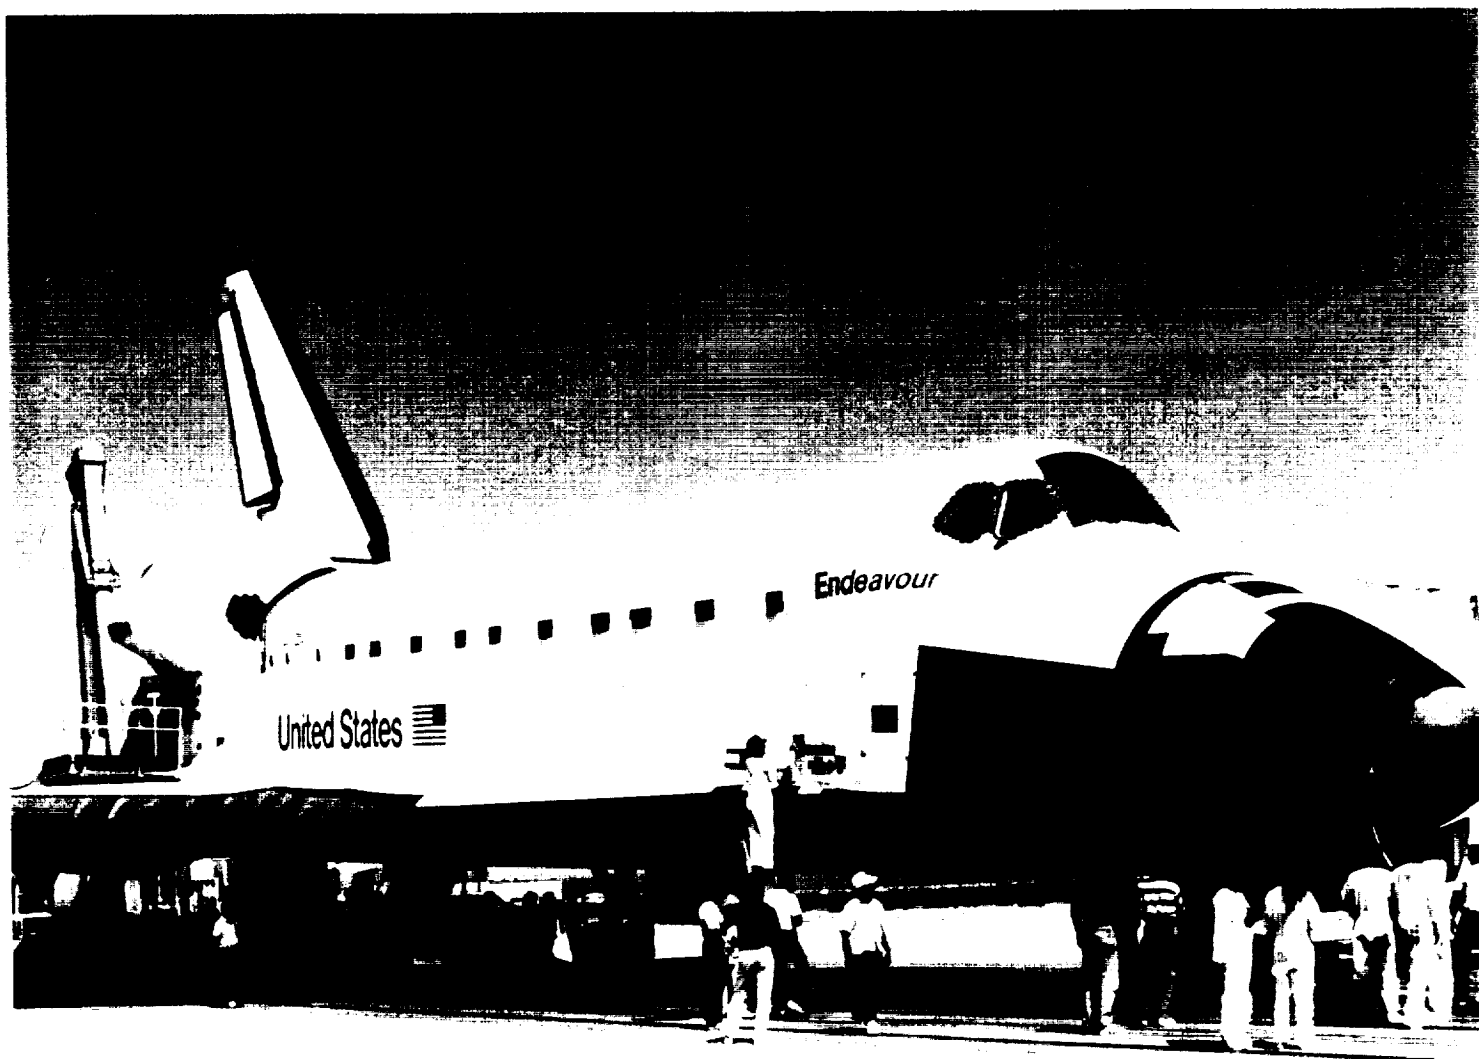
Overall view of Orbiter right side.
Note tile damage site just aft of the nose cap.

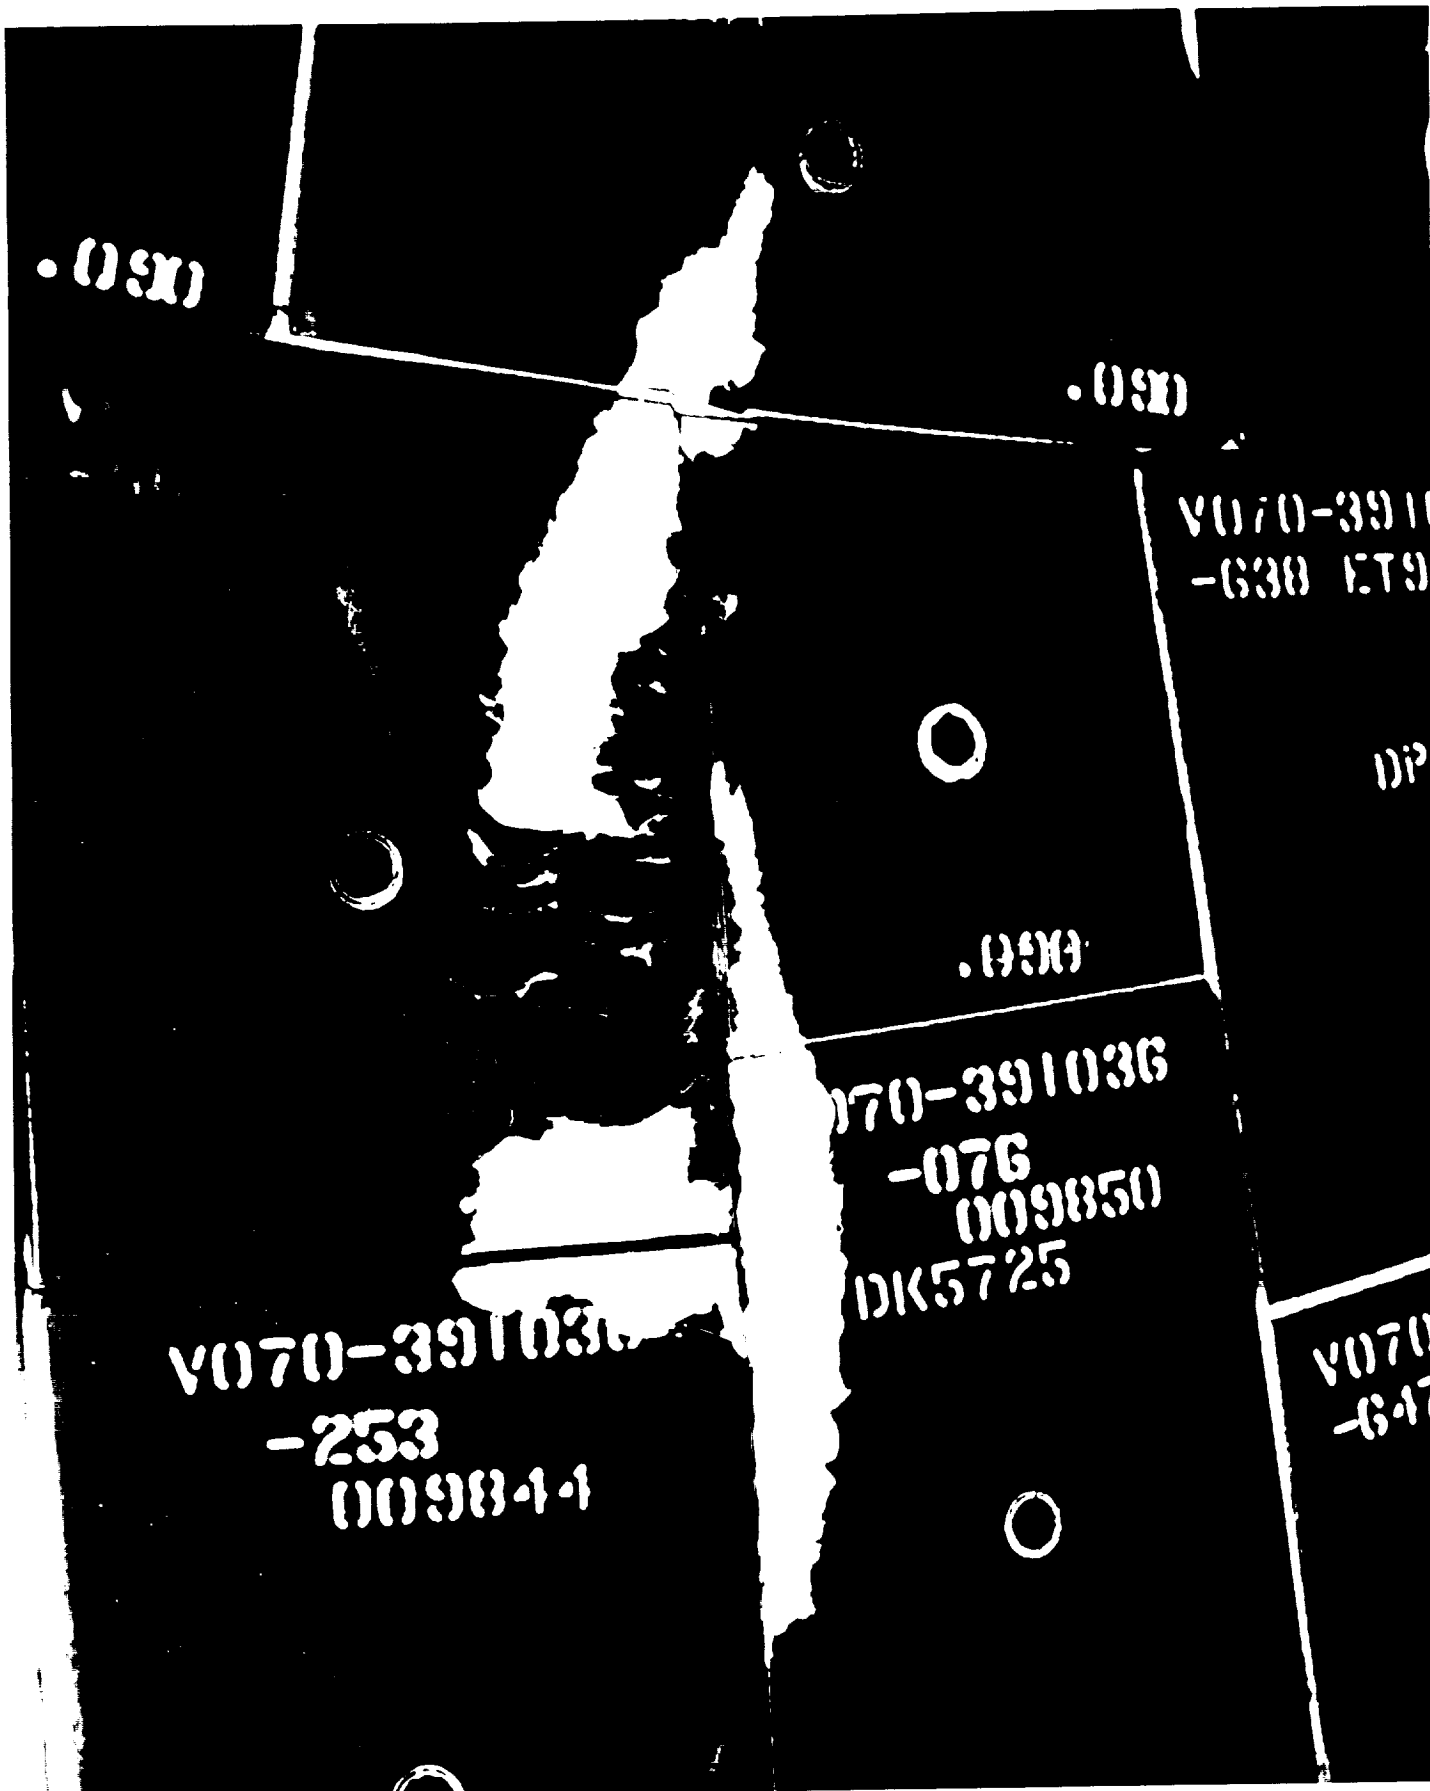
The most significant tile damage measured 9-5/8 x 2-5/8 x 1/4 inches and was located on the right side of the vehicle just aft of the nosecap RCC. The size and depth of this damage site is indicative of an impact by a low density material such as External Tank TPS foam. The following items were found on the runway underneath the RH ET umbilical door: a piece of a Jo-bolt, a spacer (washer), and a Torx head screw. Another Torx head screw was found on the runway underneath the LH ET umbilical door. This flight marked the first use of the Orbiter drag chute. According to JSC Deceleration System engineering, the drag chute functioned nominally. However, two tiles, one on the lower (-Z) edge of the drag chute opening and the other on the LH lower edge of the vertical stabilizer

Tile damage site on the right side of the Orbiter just aft of the noscap RCC measured 9-5/8 x 2-5/8 x 1/4 inches. The size and depth is indicative of an impact by a low density material such as External Tank TPS foam.

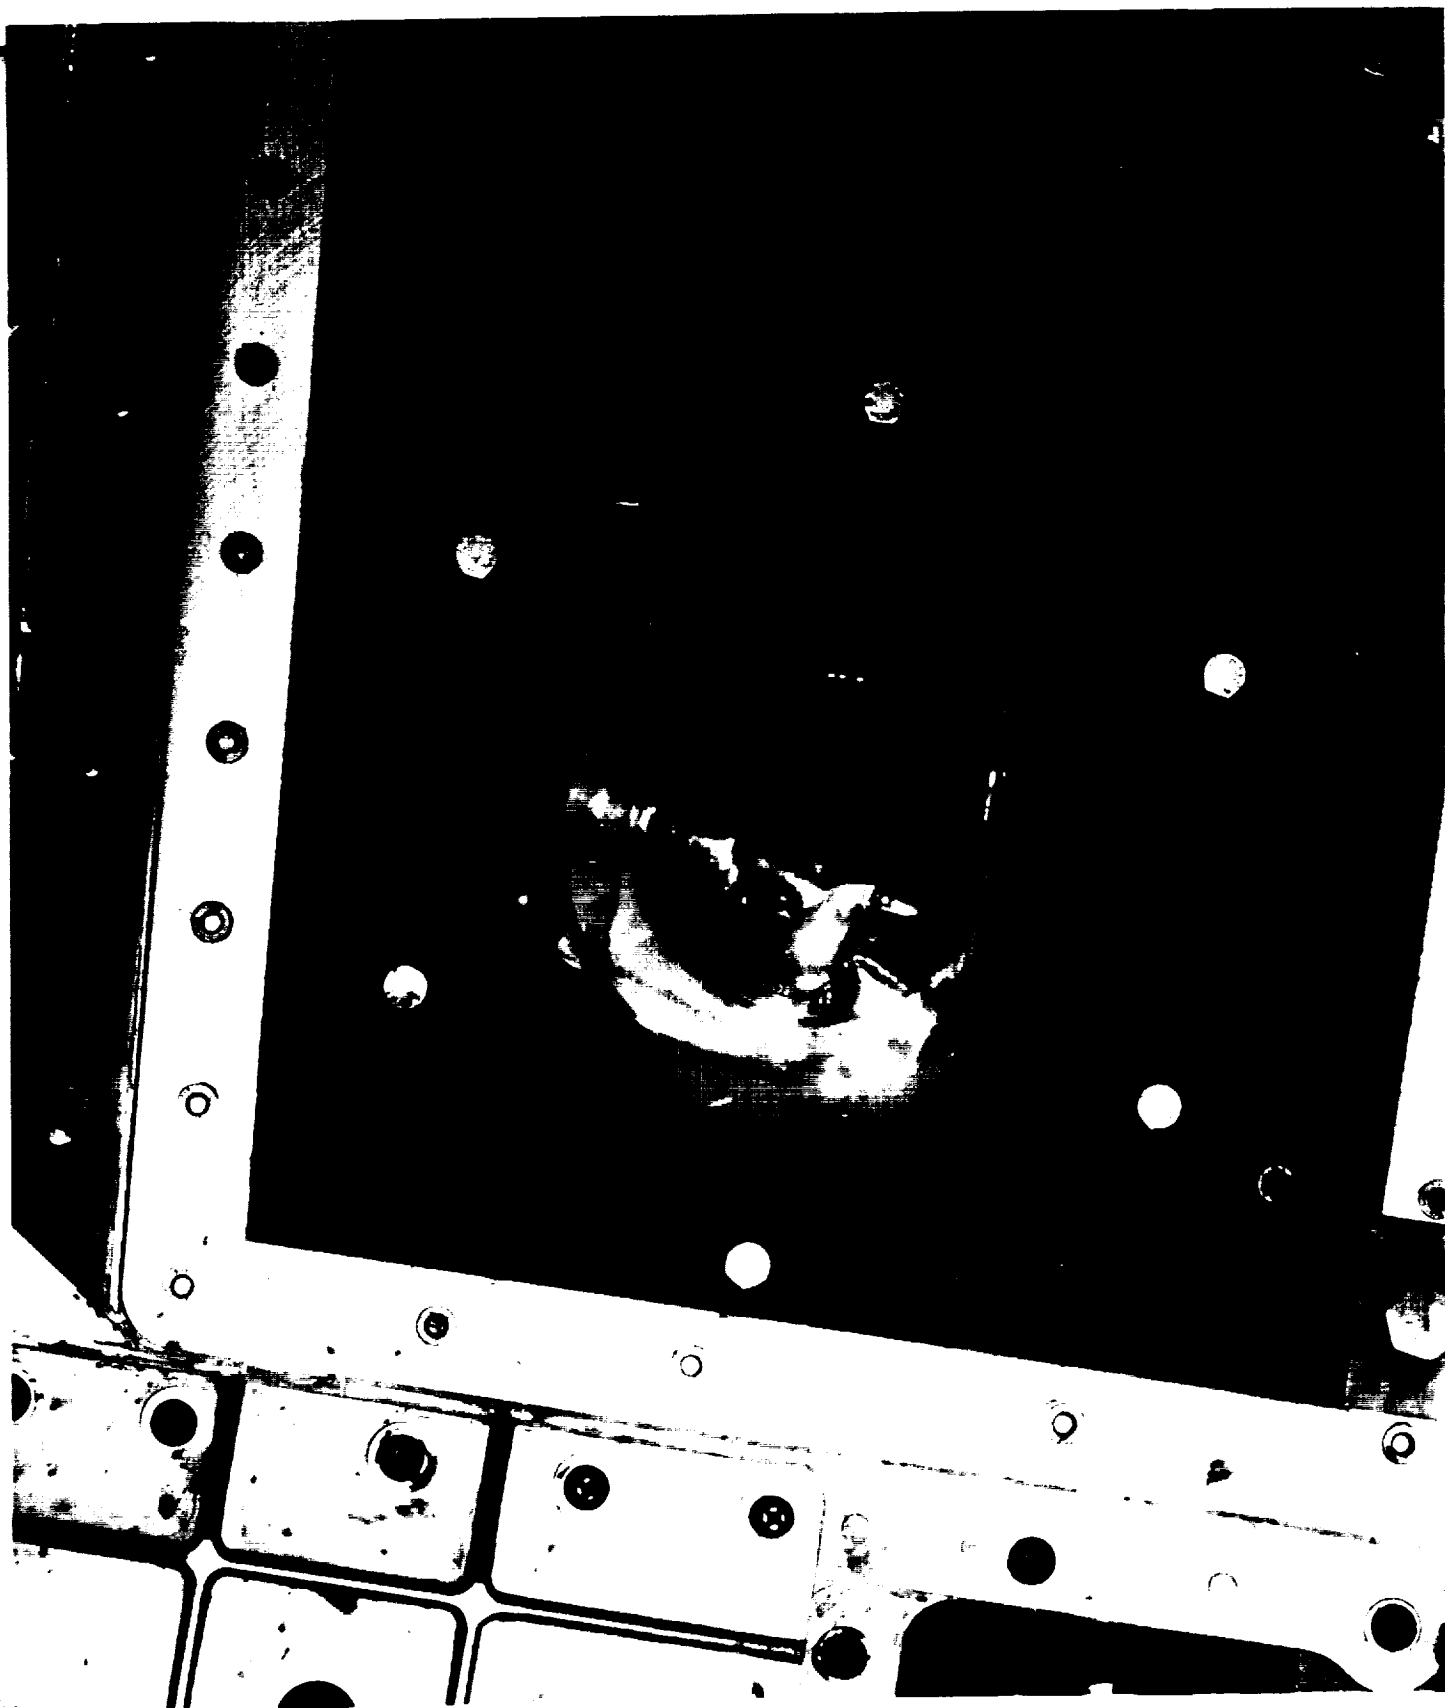
A small plastic bag was found lodged between the 16mm umbilical separation camera and the thermal window pane

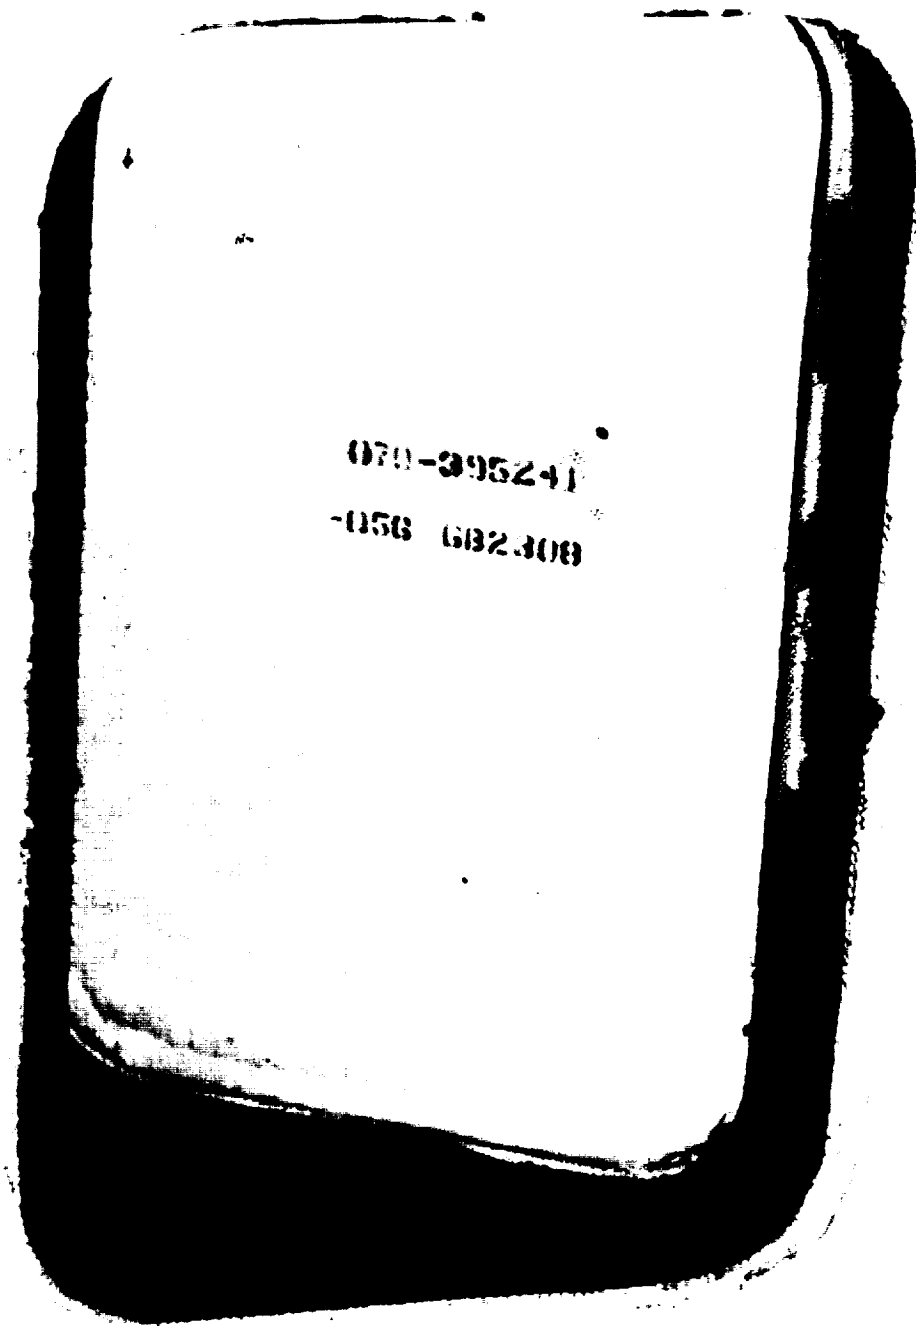
Discoloration on RH vent door #9
